## Biggetal Dam

Application Field: Technical Service  
Place: Attendorn, Germany  
Date: 2009  
Products: 2 x VAG KSS Hollow Jet Discharge Valves DN 1500

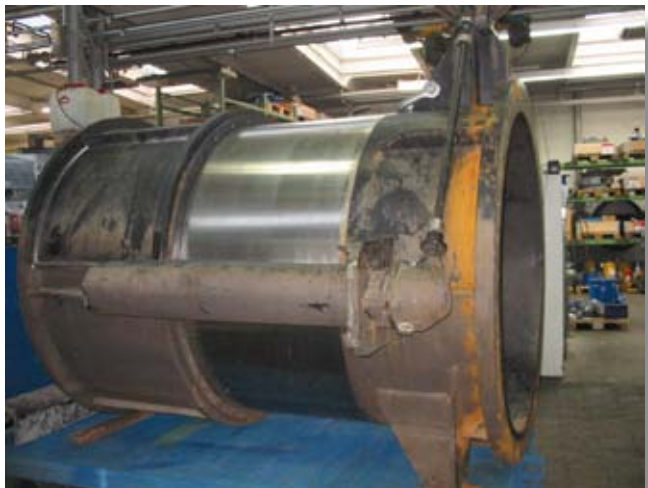
Disassembly of the 10-year-old VAG KSS Hollow Jet Discharge Valve

For rehabilitation the hollow jet discharge valves were taken to the VAG Service Center. Besides the rehabilitation of the valves, their disassembly was also intended to provide a clear picture of their condition.

After their examination and diagnosis and in coordination with the customer a new corrosion protection coating was applied, X-rays of all weld seams were taken and the latest technical developments were implemented in the context of the rehabilitation concept.

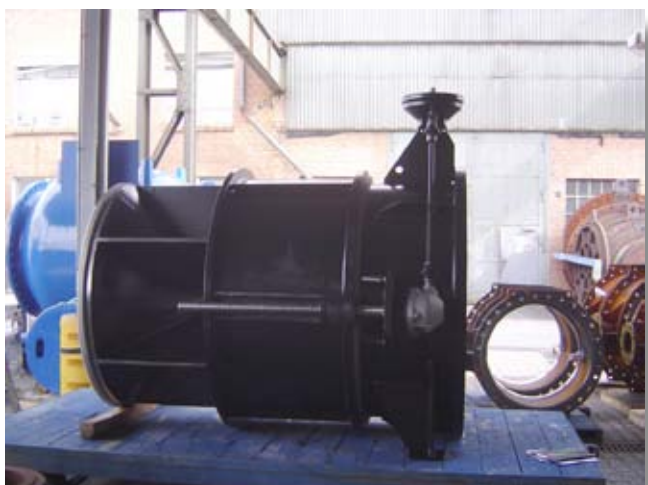
VAG KSS Hollow Jet Discharge Valves after rehabilitation
