## The Klammstein Hydropower Station

Application field: Dams / Hydropower  
Place: Lend, Austria  
Date: 2014-2015  
Products: 1 x VAG EKN® Butterfly Valve DN 2400, PN 6 with VAG HYsec PRO Hydraulic Brake and Lift Unit

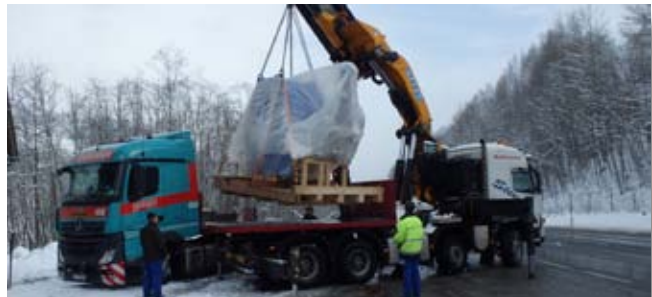
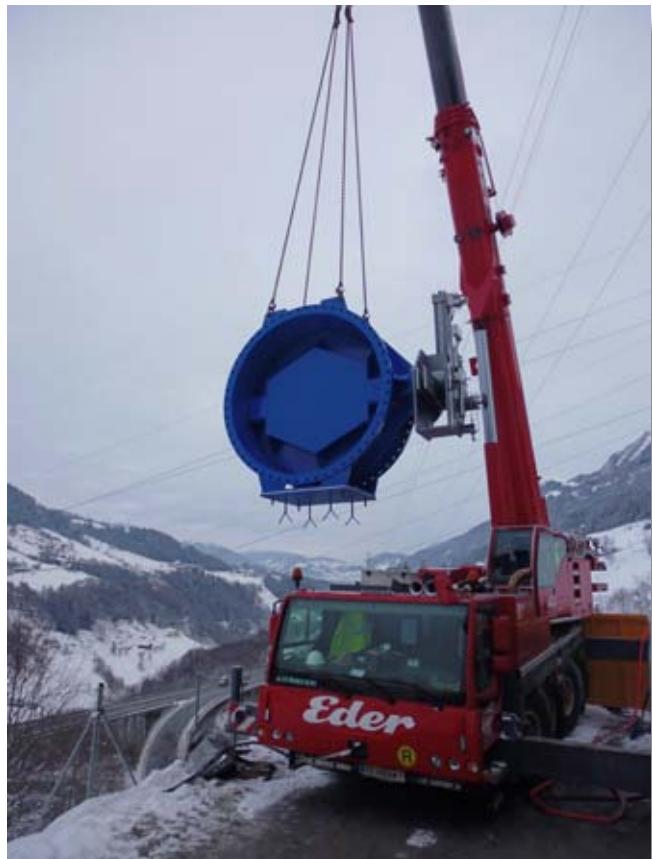
Transport of the VAG EKN® Butterfly Valve

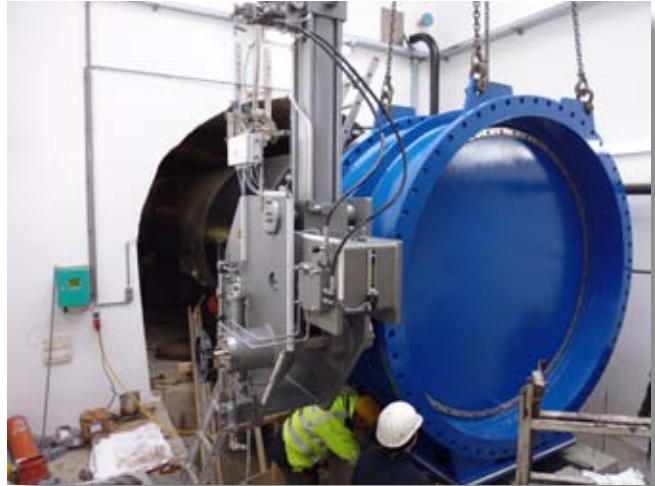
Installation of the operational valve in the structure

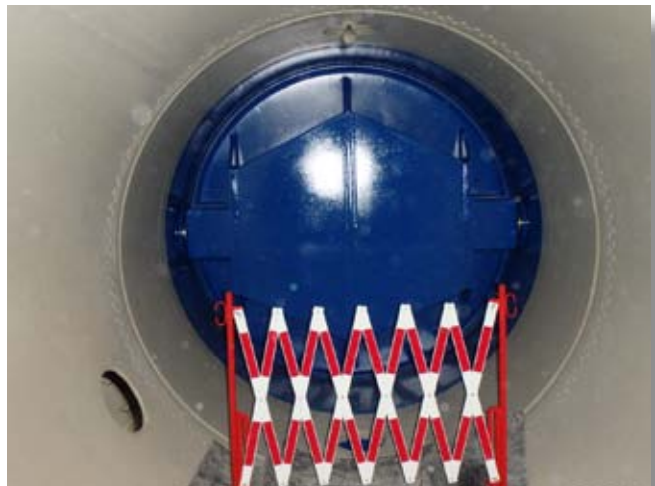
View of the pipe-burst safety valve installed inside the penstock
