REWAG, Regensburg Municipal Utility

Application Field: Technical Service
Place: Regensburg, Germany
Date: 2008-2010
Products: 4 x Erhard Plunger Valves DN 300

Project description:

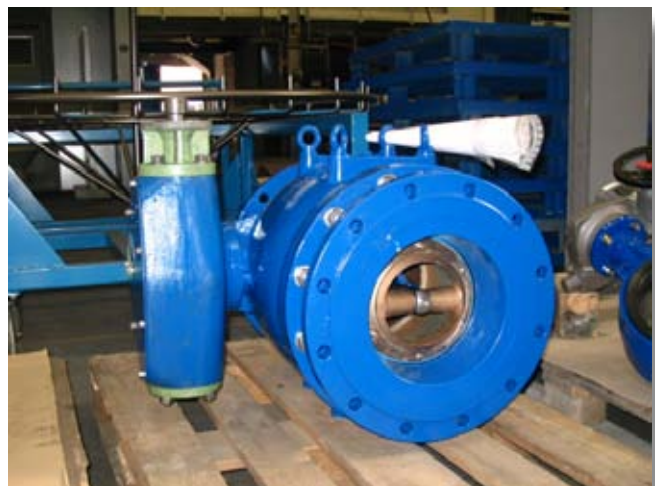
Plunger valve after its rehabilitation

To be able to make use of the design advantages of the VAG RIKO® Plunger Valve, the Erhard valves were modified in a way that allowed the use of VAG spare parts.

Modifications included the replacement of the quadring, the connecting rod, the connecting rod bearing and the crank as well as the welding on of the guide skids.
