## Refurbishment of almost 50-year-old butterfly valves in the Weisweiler power plant

**Application:** Technical Service in Power Plants  
**Place:** Weisweiler, Germany  
**Date:** 2018  
**Products:** Complete refurbishment of 2 AKL Butterfly Valves DN 2000 incl. hydraulic brake-and-lift units

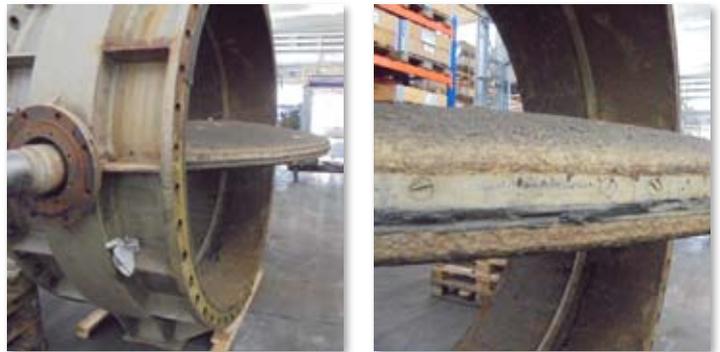
Condition of the two AKL Butterfly Valves when they were received for refurbishment in 1971

The customer dismantled both VAG AKL Butterfly Valves DN 2000 and the brake-and-lift units from the pipeline. All parts including the hydraulic brake-and-lift units were completely refurbished in VAG's Service Center in a very short time. The refurbishment included disassembly, sand blasting, the replacement of all bearing bushes and seals as well as painting. After the function check and leak-tightness test, the valves were ready for their second round of service.

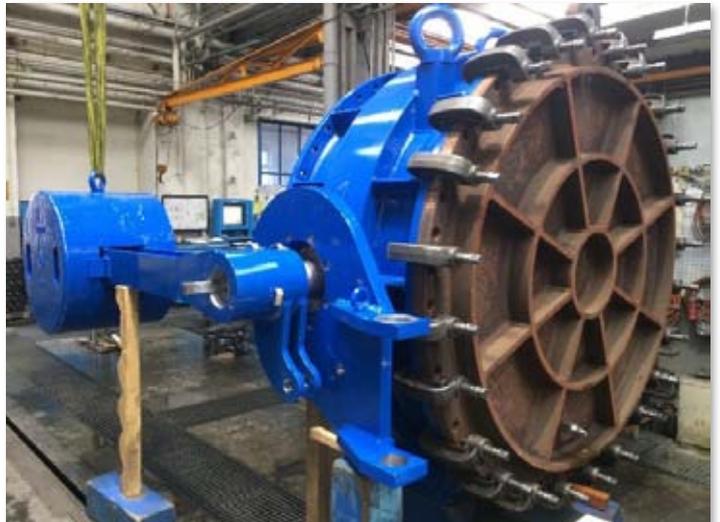
VAG Butterfly Valve during the pressure test at the Mannheim Service Center

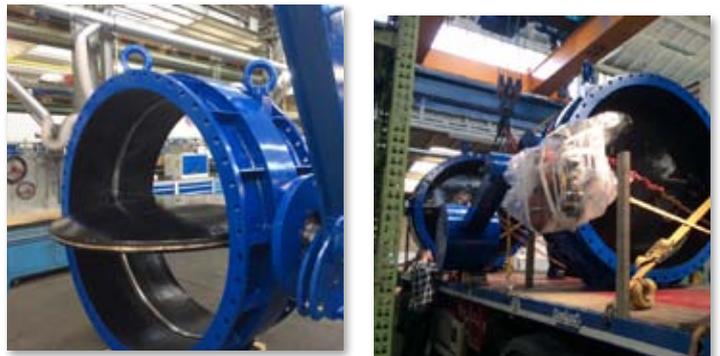
Butterfly Valves after complete refurbishment by VAG's Technical Service

When the customer had installed the refurbished butterfly valves in the power plant, VAG put the valves into service, first in dry condition including the adjustment of the closing time on the hydraulic brake-and-lift units and later on in wet condition. The acceptance inspection confirmed the trouble-free function of the valves refurbished within the four-week period scheduled and meanwhile the valves are in reliable service again.
