New safety standards for nuclear power station Unterweser, Germany

High quality, custommade
VAG valves regulate the supply
of cooling water

Project: Overhaul water intake basin
nuclear power station Unterweser

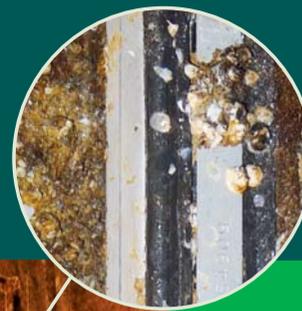
Heavy barnacle growth after just two years of operation.

In September 2009, the cross-channel was inspected and the 'new' valves tested (right photo). Barnacles had settled on the valves in large numbers, but they hadn't damaged them and were easily rinsed off with a pressure washer. The experts agree: after two years of brackish water and barnacles, the Sluice Gate Valves are in excellent condition.
